LOZIER
Home Inspections, LLC.

" Residential and Structural Pest Inspection Report " WSDA ICN # 7777BM030

Property address: 10 Rad Rd

Inspection date: Wednesday, August 22, 2007

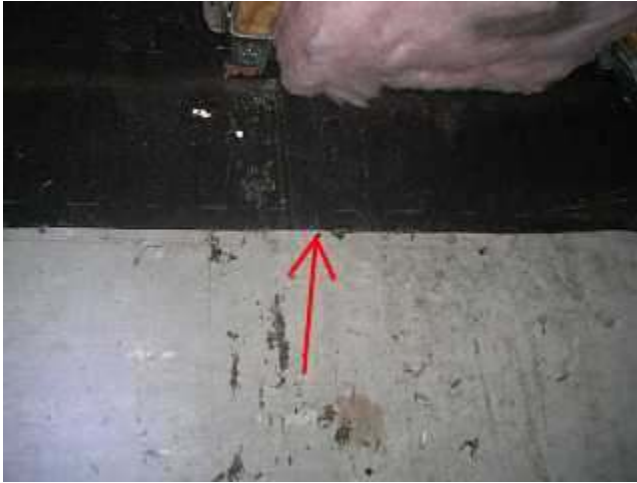
Photo 10

10) 🛠️ ⚠️ 💧 One or more crawl space vent screens are blocked by building paper. This restricts ventilation in the crawl space and may result in increased levels of moisture inside. Materials or items blocking vents should be removed.

Tar paper covering vents at perimeter.

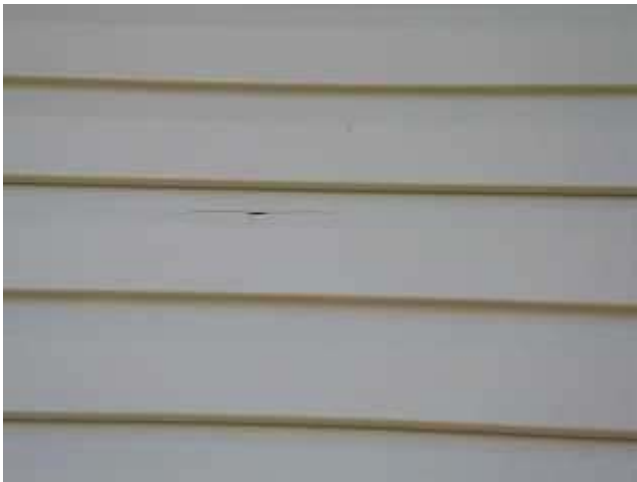
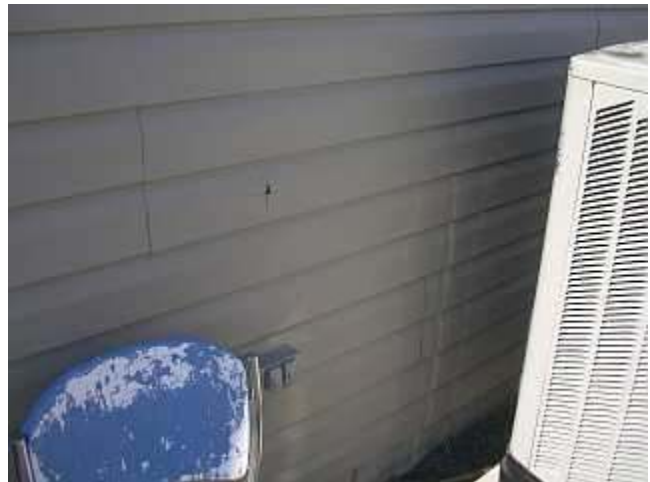
11) 🛠️ ⚠️ 💧 Siding is damaged and buckling in one or more areas. A qualified contractor should evaluate and make repairs and/or replace siding as necessary to prevent water and vermin intrusion. Homeowner stated repairs are to be made and vinyl material is on site.

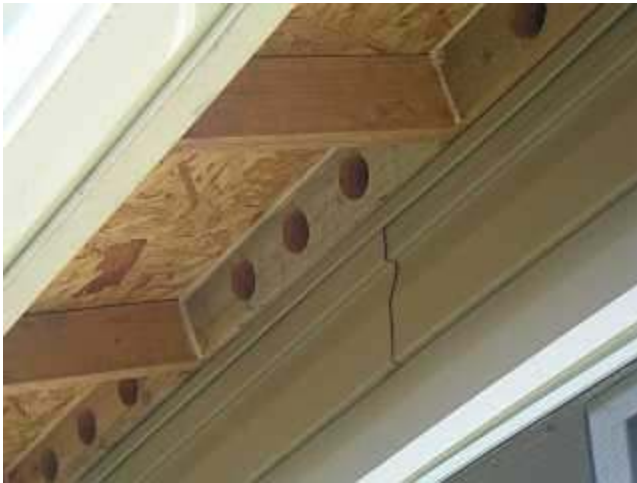
12) ⚠️ ⚠️ 💧 The exterior finish is missing on soffits. A qualified contractor should prep (pressure wash, scrape, sand, prime caulk, etc.) and paint as needed and as per standard building practices.

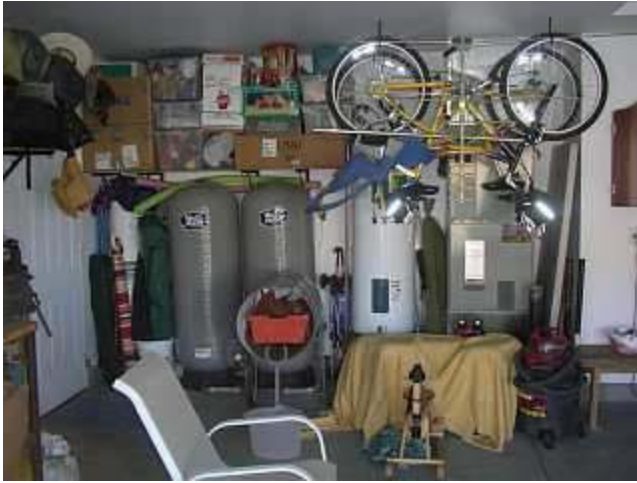
**Photo 1**

The water heater does not have seismic straps or struts installed. This is a potential safety hazard since movement can cause leaks in the gas supply lines or damage wiring. Leaks may also occur in water supply pipes. For safety enhancement we recommend client consider having a qualified contractor install seismic straps or struts as necessary and as per standard building practices.

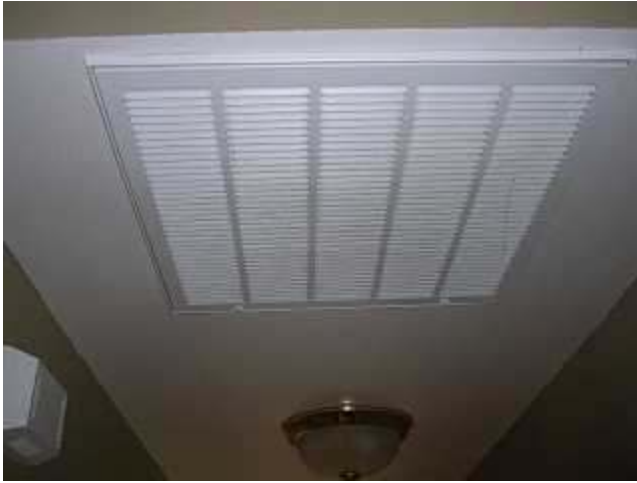
**Photo 7**

Filter behind grill in hall

Air handler filter(s) should be checked monthly in the future and replaced or washed as necessary.

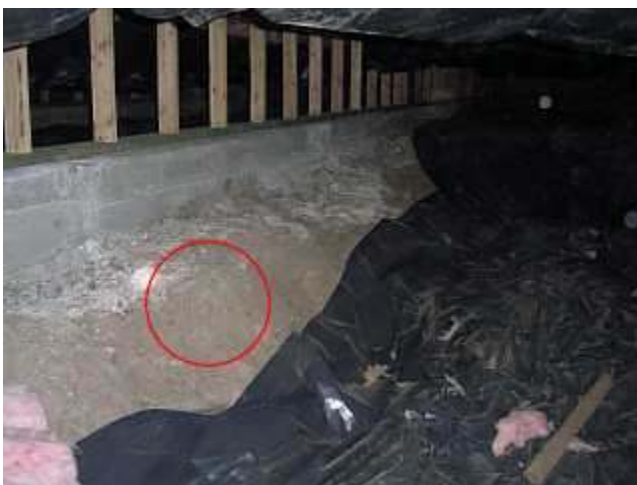
Photo 9

36) ⚠️ ⓘ The vapor barrier needs repair. Exposed soil was found in some areas. This is a conducive condition for wood destroying insects and organisms due to the likelihood of water evaporating into the structure from the soil. A qualified contractor should make repairs as necessary so no exposed soil exists. Standard building practices require the following:

bare earth, vapor barrier moved

- The soil below the vapor barrier should be smooth and free from sharp objects.
- Seams should overlap a minimum of 12 inches.
- The vapor barrier should lap up onto the foundation side walls.

- Seams and protrusions should be sealed with a pressure sensitive tape.
- The vapor barrier should be caulked and attached tightly to the foundation side walls. For example, with furring strips and masonry nails.

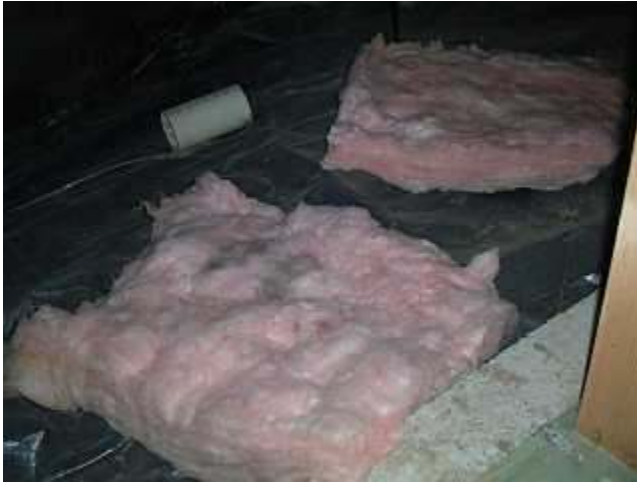
Photo 8

37) ⚠️ 💧 (Loose insulation and/or)Cellulose-based debris such as wood scraps, form wood, cardboard and/or paper were found in crawl space. All cellulose-based debris (rackable or larger) (and loose insulation) is a condition conducive to WDO/WDI and should be removed.

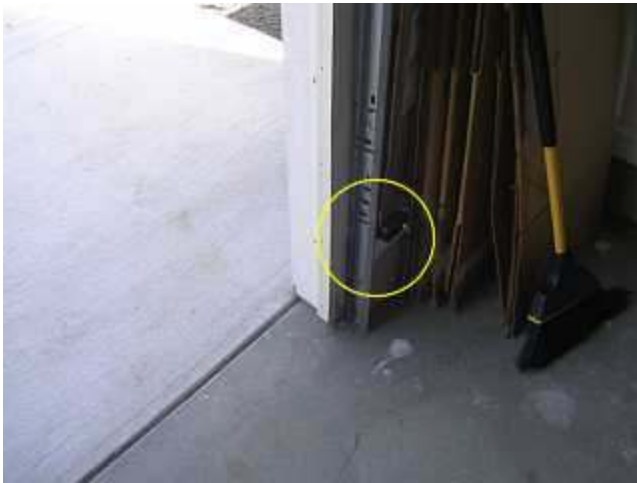
**Photo 6**

39) 🚨 🛠️ The infrared "photo eye" devices that trigger the vehicle door opener's auto-reverse feature are located higher than 4 to 6 inches from the floor. This is a potential safety hazard. A qualified contractor should relocate these devices so they're 4 to 6 inches from the floor. For more information on garage door safety issues, visit: <http://www.cpsc.gov/cpsc/pub/pubs/523.html> or <http://www.ohdstl.com/safety.html>

Recommend lowering to 4-6" for safety
