LOZIER
Home Inspections, LLC.

" Residential and Structural Pest Inspection Report " WSDA ICN # 7777BM030

Property address: 10 Rad Rd

Inspection date: Wednesday, August 22, 2007

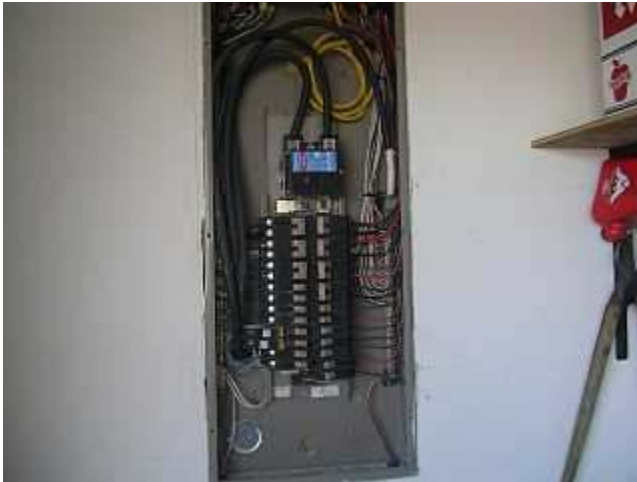
Photo 3

All AFCI and GFCI function as intended, interior of panel looks good, no visible defects

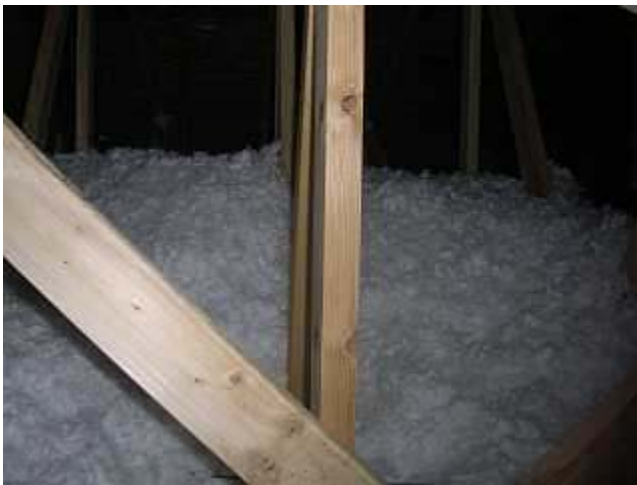
Photo 4

In accordance with our standards of practice (www.nachi.org) and for safety reasons.... we do not enter attics that have less than 36 inches of headroom, where hatch opening is smaller than 20X30 or blocked, where mobility is restricted or hazardous, or is restricted/blocked by ducts or stored items, or where insulation obscures the joists or there is a possibility of damage to insulation. Therefore these areas will be inspected the best we can from the access point. All inaccessible attic areas are excluded from this inspection. With regards to evaluating the type and amount of insulation on the attic floor, we do not test or sample the material for specific identification, and depth measurements will be approximate. We do not move or disturb any portion of the insulation, and it may well cover and obscure water pipes, electric junction boxes and wiring, exhaust vents and/or other components. An access/inspection option is permanently installed walkways if applicable, and we recommend these be installed by a qualified professional, so that periodic inspection of attic areas can be made.

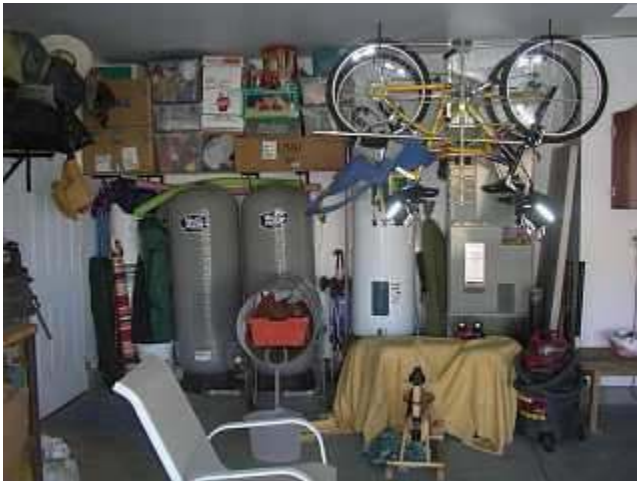
**Photo 1**

The interior perimeter of the garage is excluded from this inspection due to lack of access from stored items.
